LINDE AG Linde Engineering Division	Damage of Transfer Line Exchanger Tube	Document No.
		TRT 17 So 026
Proj. No.: 3130 BGWM	Code: BANDAR_IMAM_JS1	Page 1 of 5

Target of this investigation is to find the root cause of this failure and to give recommendation for planned repair work on site.

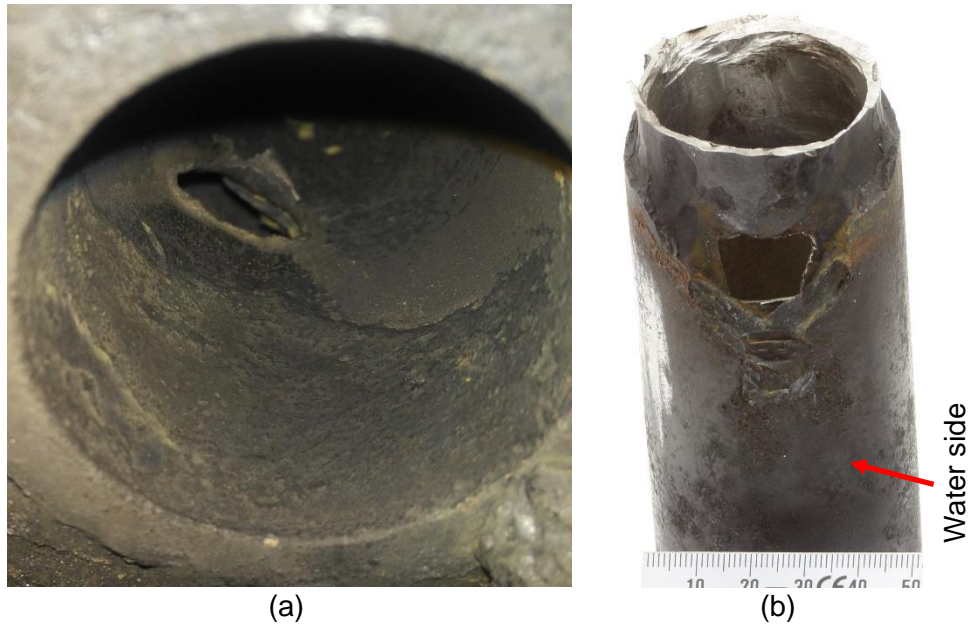
The original double tube TLEs of Amir Kabir Petrochemical plant. 6 out of 7 TLEs were replaced by locally manufactured after 10 years of operation. AKPC uses 5 liquid feed furnaces (Naphtha) and 2 gaseous feed furnaces (see Fig. 1.1). The design of double tube TLE of liquid and gaseous feed differs slightly (refer to Fig. 1.2, Fig. 1.6 and Fig. 1.7) in which the TLEs of gaseous feed furnace have more tubes (Naphtha = 36 tubes, Gas = 60 tubes) and the water inlet for the liquid feed furnace is only on one side compared to two sides for gaseous. After 15 months of operation 4 leaks occurred in 4 different TLEs. The operational history of furnace No. 4 is shown in Fig. 1.3. Fig. 1.4 shows the damaged tube of furnace 4 (TL 1411C) in which the leak caused an immediate furnace shut down (BFW ingress into the cracked gas stream). During the site visit, TL 1511A (furnace 5) had a leak were almost the entire circumference of the tube was damaged as seen in Fig. 1.5.

Fig. 1.4: View of the damaged tube of the TLE (furnace 4, TLE C); (a) In position inside the TLE (crack gas side); (b) After removing from TLE (view from water side). The edges were grinded while removing the welding seam to tube sheet.

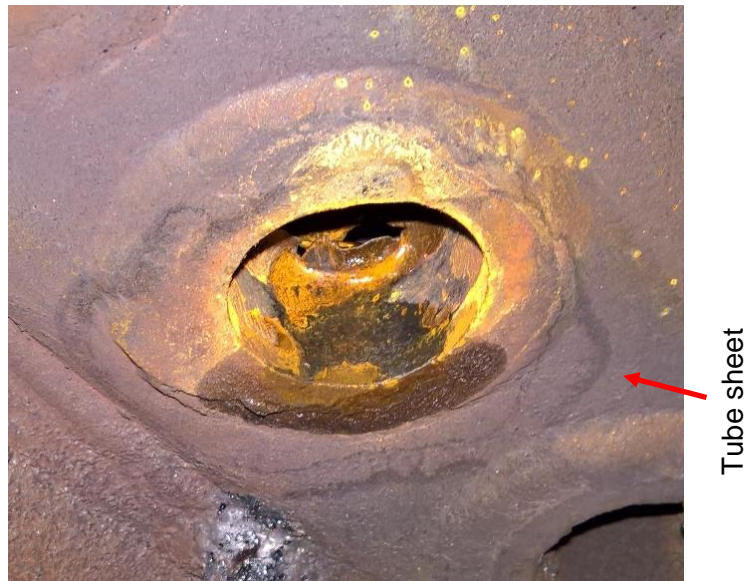
Fig. 1.5: View of the damaged TLE tube of furnace 5, TLE A. Almost the entire circumference of the tube was almost damaged (location is 3-4 cm away from tube-sheet).

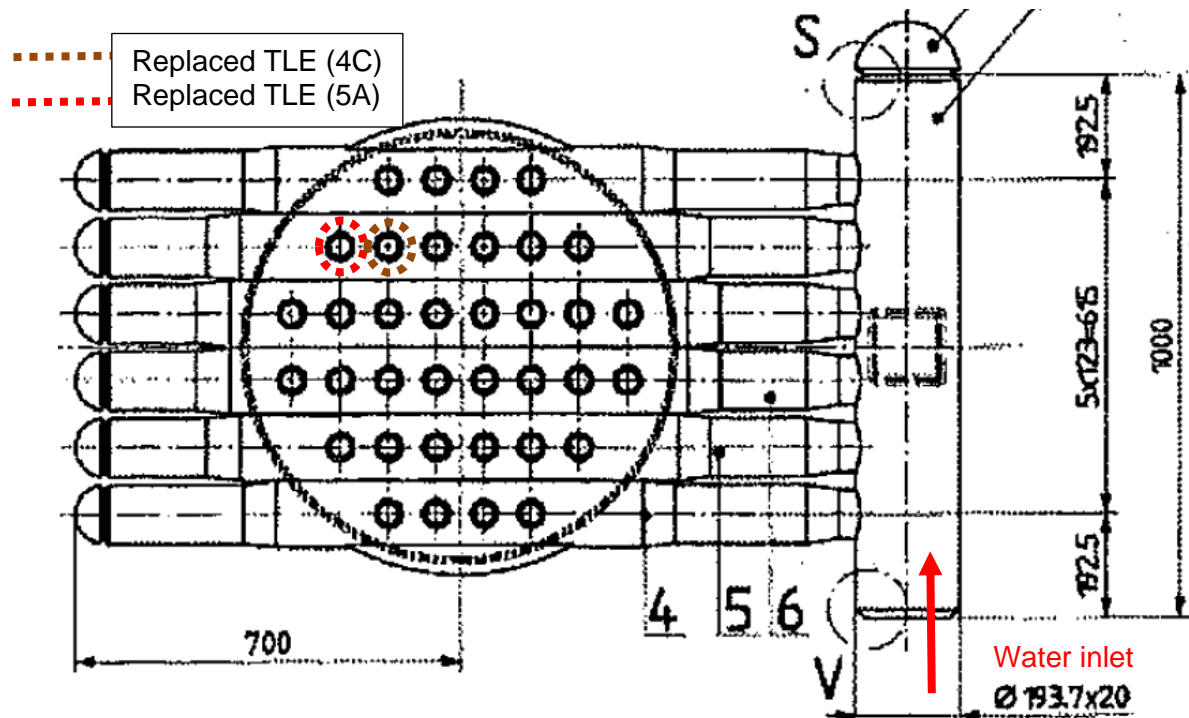
The locations of failed tubes are seen in Fig. 1.6 and Fig. 1.7 for liquid and gas feed respectively.

Fig. 1.6: Overview of tube sheet drawing of Naphtha cracking furnace with position marking of the damaged tubes. In total 3 damages took place till date on this TLE type (the position of the 3rd damage is unknown)

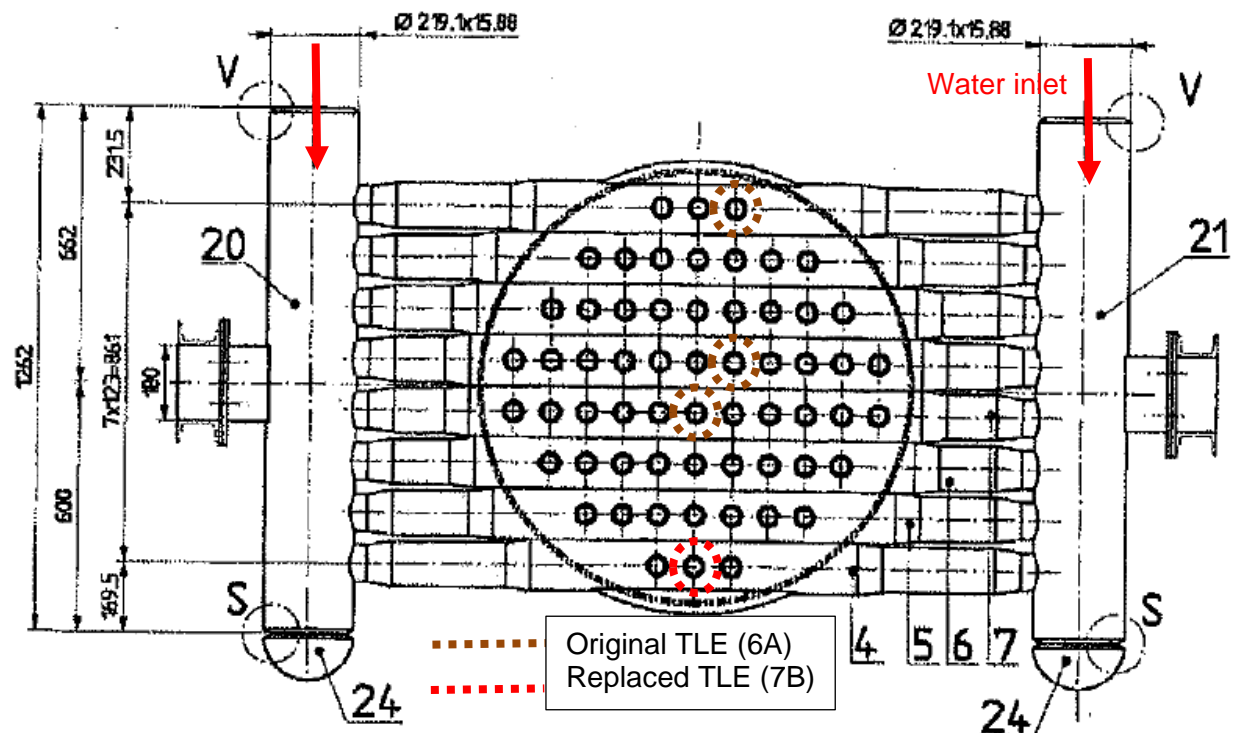
Fig. 1.7: Overview of tube sheet drawing of gas cracking furnace with position marking of the damaged tubes. The red marked tube represents the damaged of the replaced TLE. The brown circle represents the damaged tubes of an original TLE of furnace 6 still available on site.

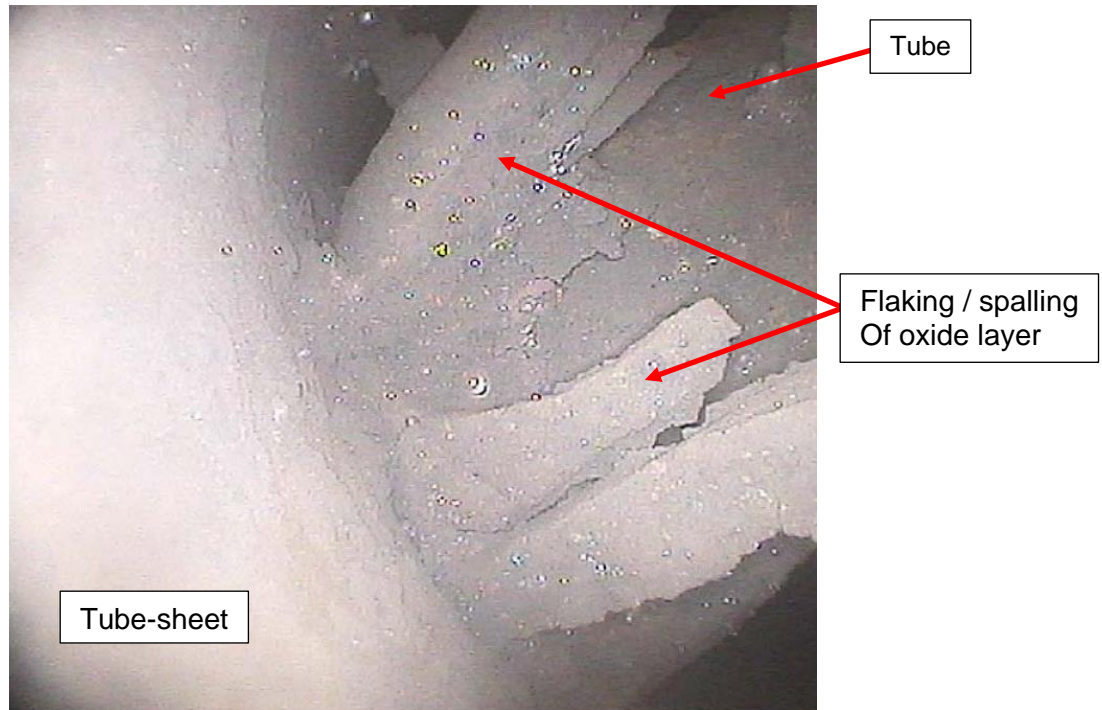
A borescope was used to inspect inside the TLE 4C (TL 1411C). The image helped to select the right samples. As seen in Fig. 2.1, the flaking /spalling of oxide layer visible starting from the tube to tube-sheet (oval header) interface point and extending roughly up to the height of 4–5 mm of the tube. Inside the oval header deposits and corrosion products were covering the tube-sheet/oval head surface. Tube-sheet front view (cracked gas inlet side) of TLE 4C is seen in Fig. 2.2 after removing of samples. For a better sample identification, the samples are re-numbered as per their position within tube sheet. The back side of oval header (internal surface) and outer tubes are seen in Fig. 2.3 and Fig. 2.4 representing the 2nd and 3rd row tube sheets respectively where the oval header is filled with corrosion product. In Fig. 2.5, the 5th tube of 6th row which was cut as investigation sample is shown (same tube as demonstrated in Fig. 2.1). The tube is located at the end of the oval header (last tube of the row). After cutting, great amount of loose scale fell off. The corroded parts are at the backside of the tube, with respect to the flow direction, as seen in Fig. 2.6. For further investigation, four samples were cut out of the tube from which sample 1 and 2 are from corroded surface and are located on back side of the pipe (opposite side of flow direction). Sample 3 and 4 are located on the front side of the tube/perpendicular to the flow direction. In the same manner, sample 1 and 3 are at the same height and opposite each other (located next to the tube sheet). The same applies for sample 2 and 4 (located further away from the tube sheet) as seen in Fig. 2.6. The

Fig. 2.1: Borescope image of TLE tube (row 6, position 4) of furnace 4, TLE C. The flaking /spalling of oxide layers is seen. Based on this image, this tube was selected as a sample for this investigation (see Fig. 2.5).

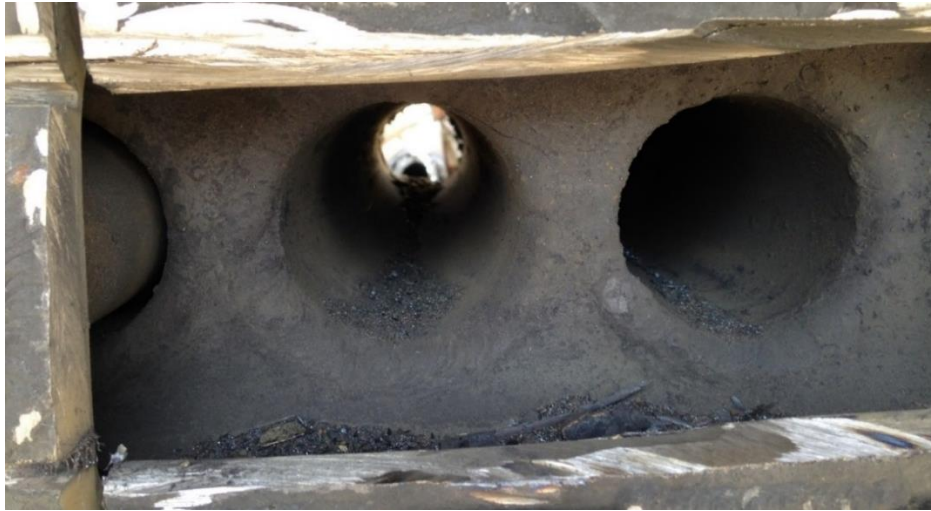
Fig. 2.3: View of the cut tube sheet marked as TS 2 in Fig. 2.2. Position: 2nd row, tube No. 3 and 4. No abnormality is seen.

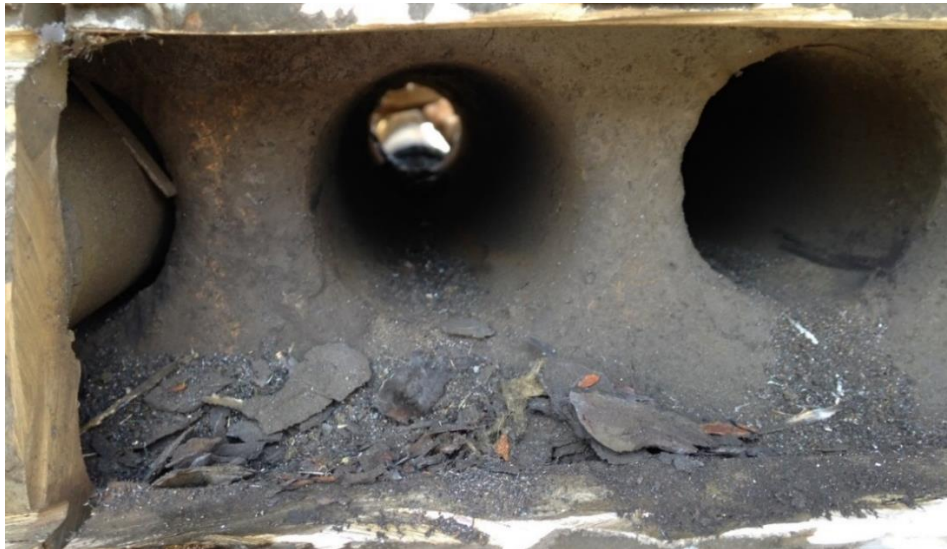
Fig. 2.4: View of the cut tube sheet marked as TS 3 in Fig. 2.2. Position 3rd row, tube 4 and 5. No abnormality is seen.

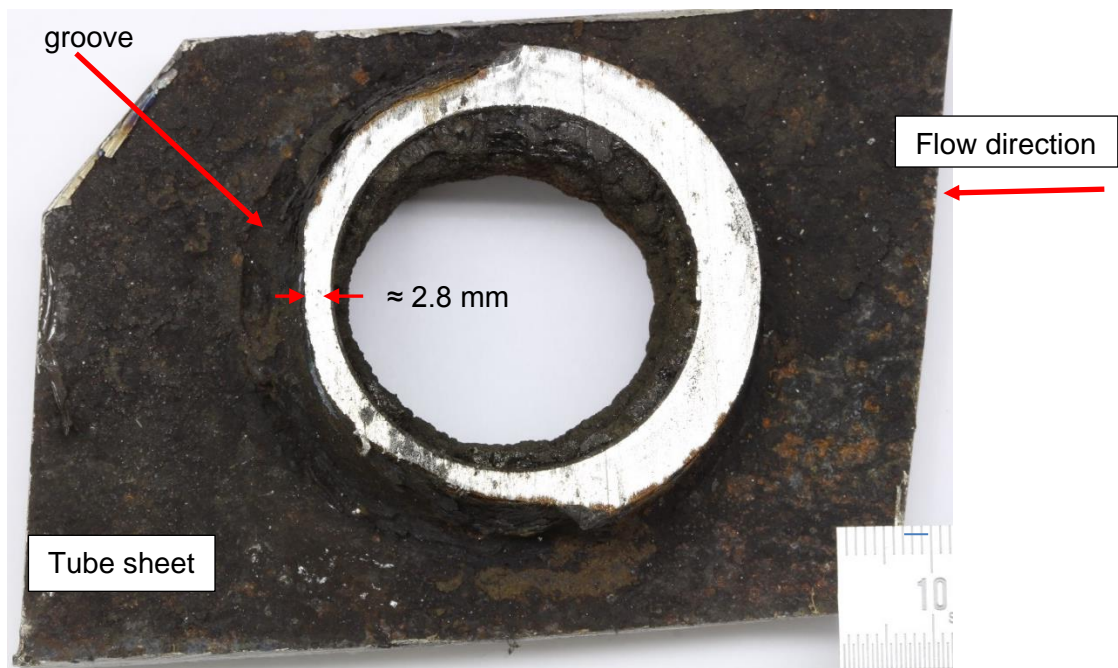
circumference of inner tube is seen in Fig. 2.7 in which the material loss (tube wall thickness) of the tube with respect to flow direction is clearly documented.

Fig. 2.7: Top view of the cut pipe of the as seen in Fig. 2.5 and Fig. 2.6 b. The tube is partially covered with coke from inside. The corrosion of the tube is clearly seen on the back side of the flow in form of material loss.

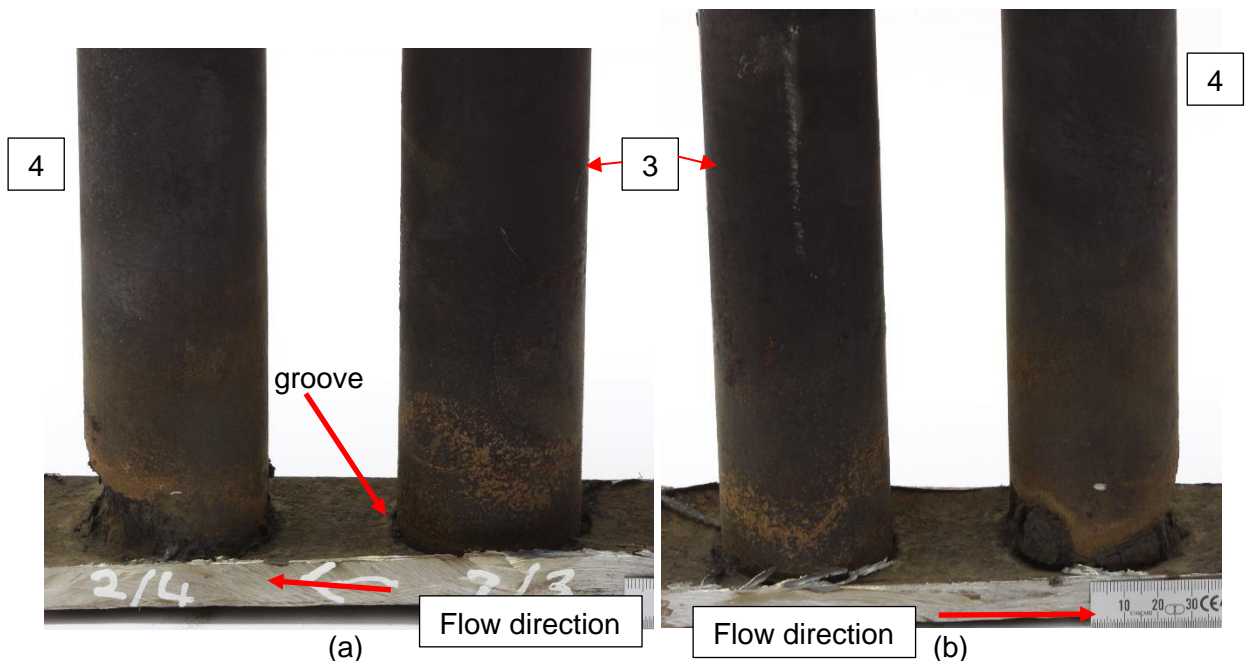
The cut tube sheet samples of 2nd and 3rd rows (TS2 and TS3 as in Fig. 2.2) are seen in Fig. 2.8 and Fig. 2.9. The tube sheet lost 4 mm of the thickness and corrosion on tube is started at the groove (refer to Fig. 2.9).

Fig. 2.8: Front and back side view of sample TS2 (with respect to flow direction) as seen in Fig. 2.2. Flow direction is given in both figures. The tube sheet represents the 2nd row of TLE C of furnace 4. Tubes are the 3rd and 4th in row with respect to flow direction. The 4th tube is totally highly corroded in a position on the back side of the flow at a position next to welding groove. Tube No. 3 shows some surface corrosion traces but no flaking is seen.

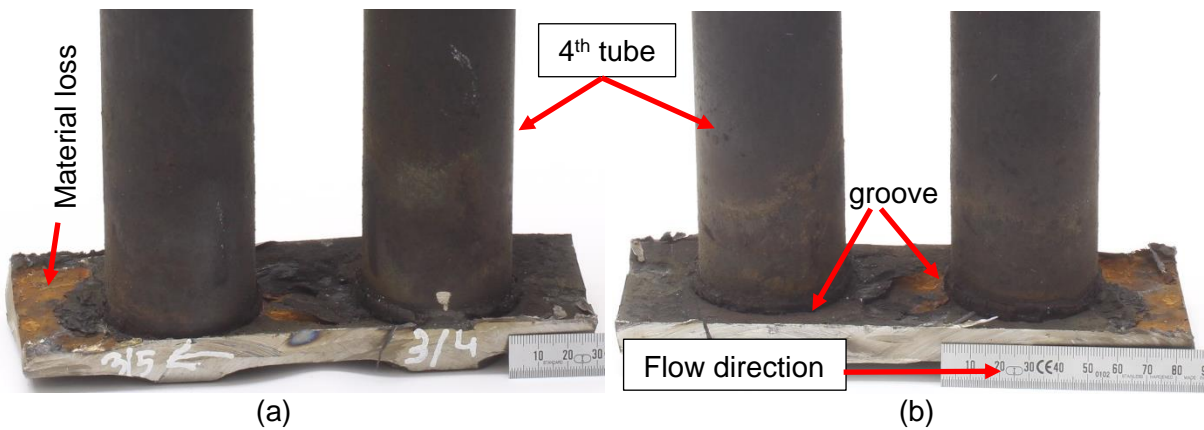
Manufacturing residues/leftovers found inside oval header and large grooves between tube-sheet and tubes are signs of improper manufacturing.

Fig. 2.9: Front and back side view of sample TS3, 3rd row of TLE C of furnace 4, (with respect to flow direction) as seen in Fig. 2.2 with flow direction given. Tubes are the 4th and 5th in row with respect to flow direction. The tube sheet lost 4 mm of the thickness. Corrosion on tube is started at the groove as seen above.

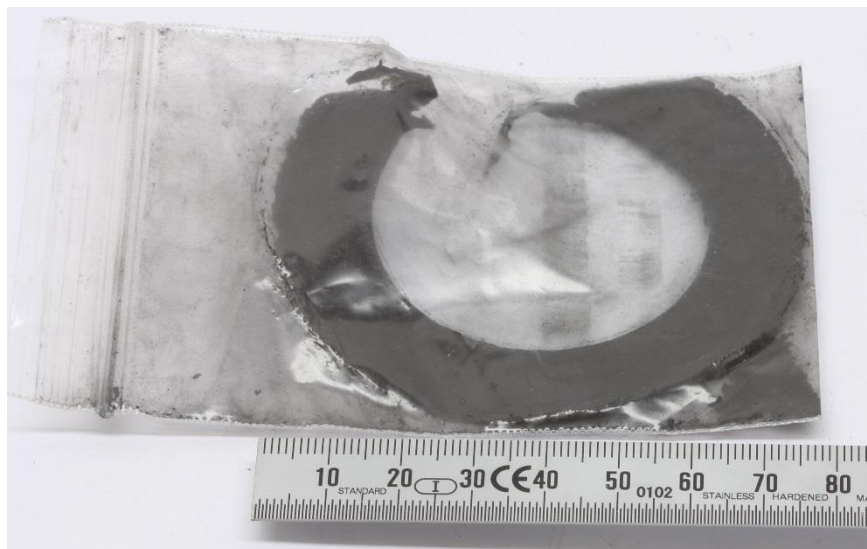
Fig. 2.10 shows manufacturing residuals / leftovers found during borescope inspection within the oval header of TLE 4C.

Fig. 2.10: View of leftover /manufacturing residuals within the oval head of TLE C of furnace 4. During the borescope inspection of TLE 4C, this piece was found within the oval head.

- Mechanical cleaning of oval header from residuals.
- Chemical cleaning just prior to start up.
- Exclusion of process up-sets in BFW treatment (also short-term) causing S, P, Ca, and Cl deposits.
- Welding with full penetration.
- Welding as per the original WPS and potential repair welds shall not affect flow conditions.

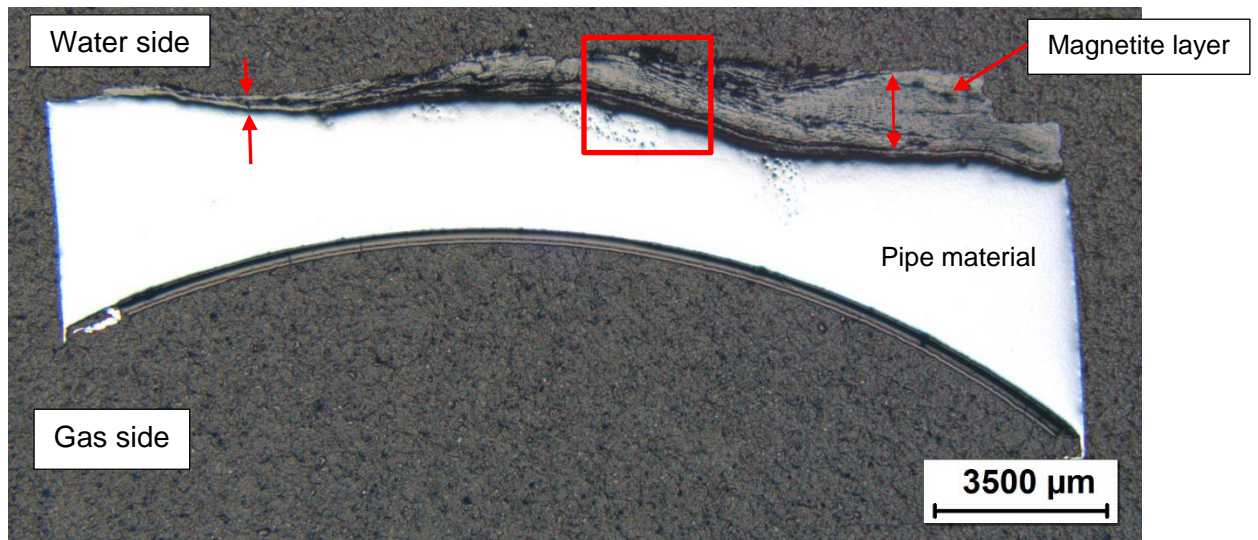
The cross sections of samples cut from TL 1411C as shown in Fig. 2.6 were metallographically investigated. Fig. 4.1 shows the cross section of sample 2, (refer to Fig. 2.6 for location) where the material loss on water side is clearly seen. The thickness of magnetite layer is not uniform on the cross section. The inhomogeneous/instable magnetite layer is cracked and deposits are concentrated between the base material and magnetite layer as seen by scanning electron microscopy (SEM) in Fig. 4.2. The layer formation is not as expected for a stable magnetite layer known in steam systems. Surface of sample 4 (located at same height to sample 2) is seen in Fig. 4.4 and Fig. 4.5 which shows a magnetite layer much thinner than that of sample 2. In addition the material loss is very low in this location. Furthermore, cross section of sample 1 which is located on the back side of the tube (with respect to flow direction) and next to the tube-sheet was inspected as in Fig. 4.7 and Fig. 4.8. The inhomogeneous magnetite layer consist mainly of porous layer.

Fig. 4.1: Metallographic image of sample 2 cross section (see Fig. 2.6). The material loss is seen on the cross section as well as the magnetite layer thickness difference throughout the cross section. The red marked area is seen in Fig. 4.2.

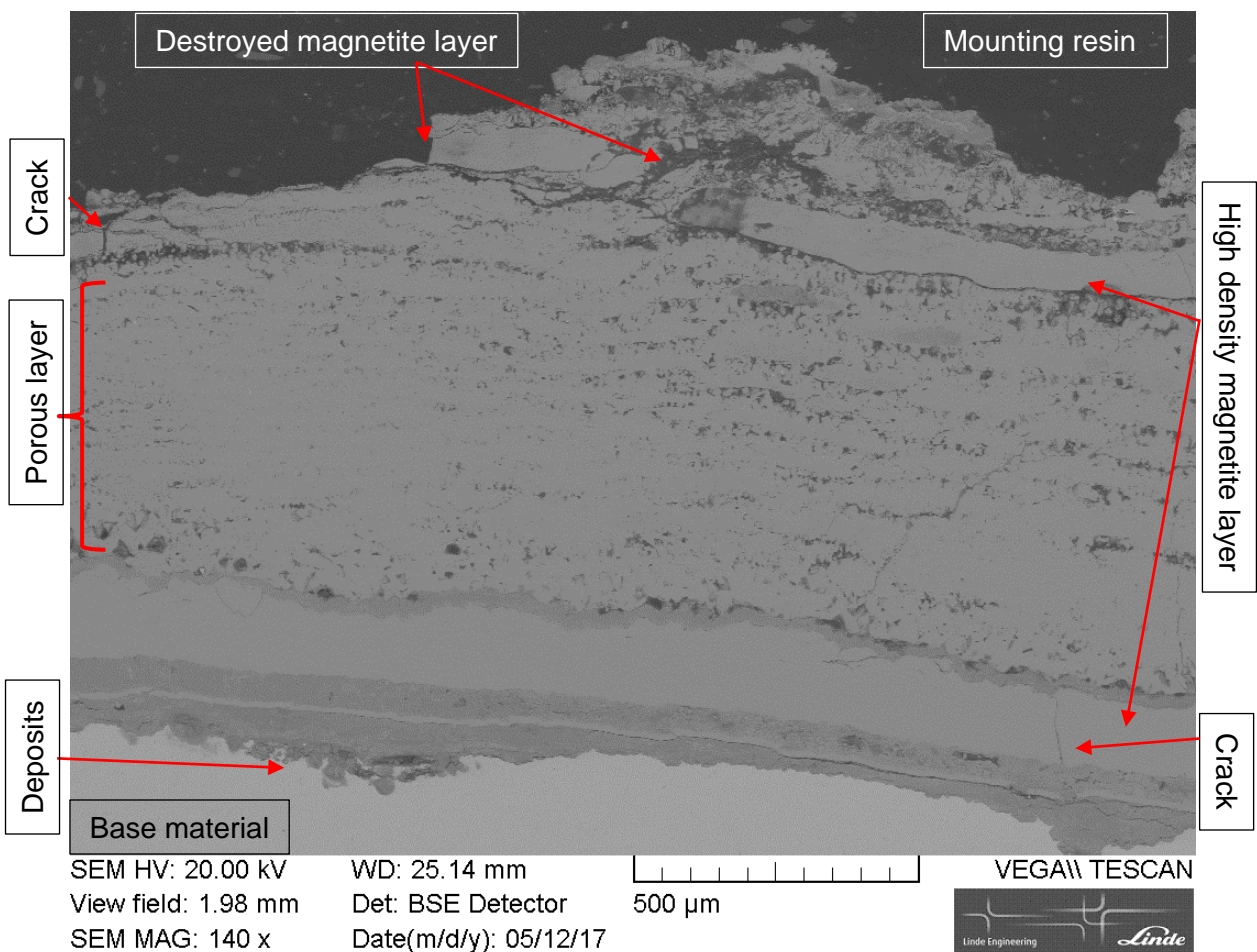
The structure of the magnetite layer was identified to be inhomogeneous and does not appear like a stable magnetite layer typically known from adequate treated steam system, and hence the magnetite layer was providing no protection and the destroyed oxide layer was flaking/spalling continuously. The deposits (i.e. S, P, Ca and Cl) found underneath the magnetite layer promote corrosion when electrolyte (i.e. water) is available. The magnetite layer is created ideally after chemical cleaning of carbon steel surface followed by immediate operation. Misconducting or missing of this step could be the main reason of the instable / inhomogeneous magnetite layer.

Fig. 4.2: SEM (Scanning Electron Microscopy) image of sample 2 for the area seen in Fig. 4.1 (for location of S2 refer to Fig. 2.6). The inhomogeneous multi-layer magnetite is seen covering the base material. The high-density magnetite layer is available twice, which is partly destroyed and cracked. A layer of deposit is available underneath the hard magnetite layer.

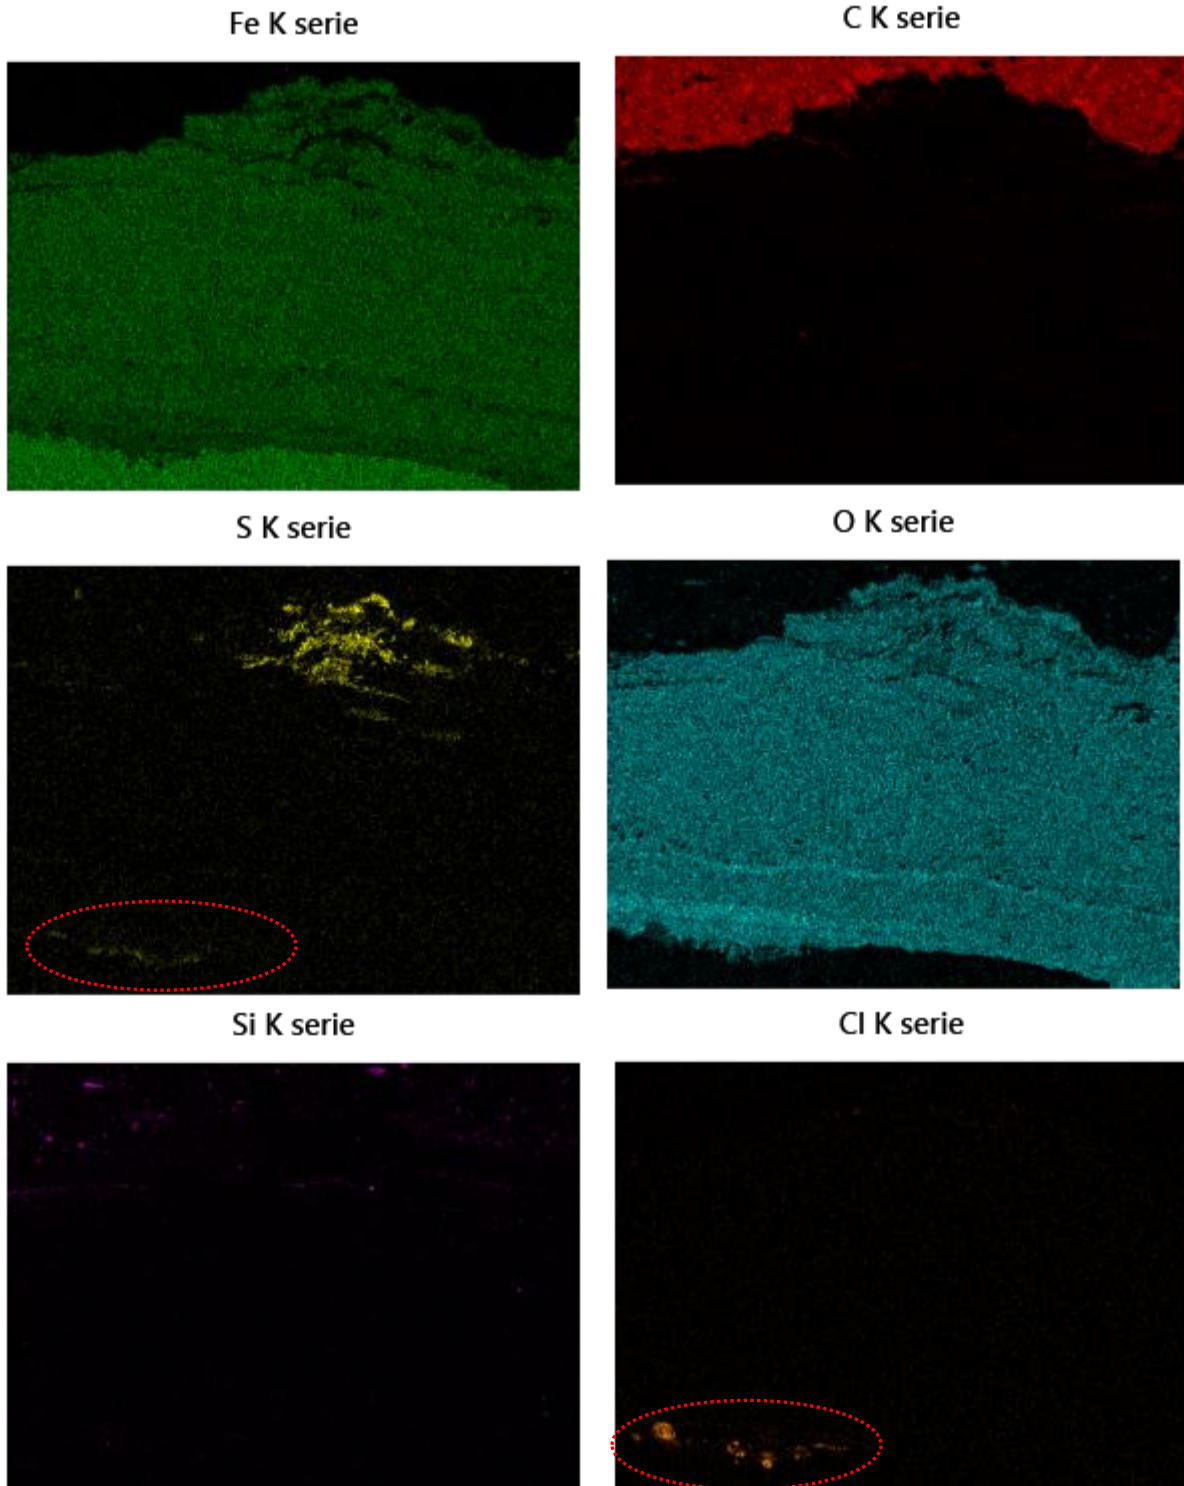
An elemental mapping analysis technique is used to analyse the surface of cross sections of sample 2, sample 4 and sample 1 where the results are shown in Fig. 4.3, Fig. 4.6 and Fig. 4.9 respectively. Sample 2 showed the concentration of S and Cl underneath the magnetite layer (refer to Fig. 4.3). Sample 4, as in Fig. 4.6, shows Ca and P within the whole magnetite layer. Sample 1 as in Fig. 4.9, shows of Ca within the porous layer as well as S and P underneath the magnetite film.

Fig. 4.3: Mapping of sample 2 of the surface shown in Fig. 4.2. The mapping showed the availability of S and Cl underneath the magnetite layer.

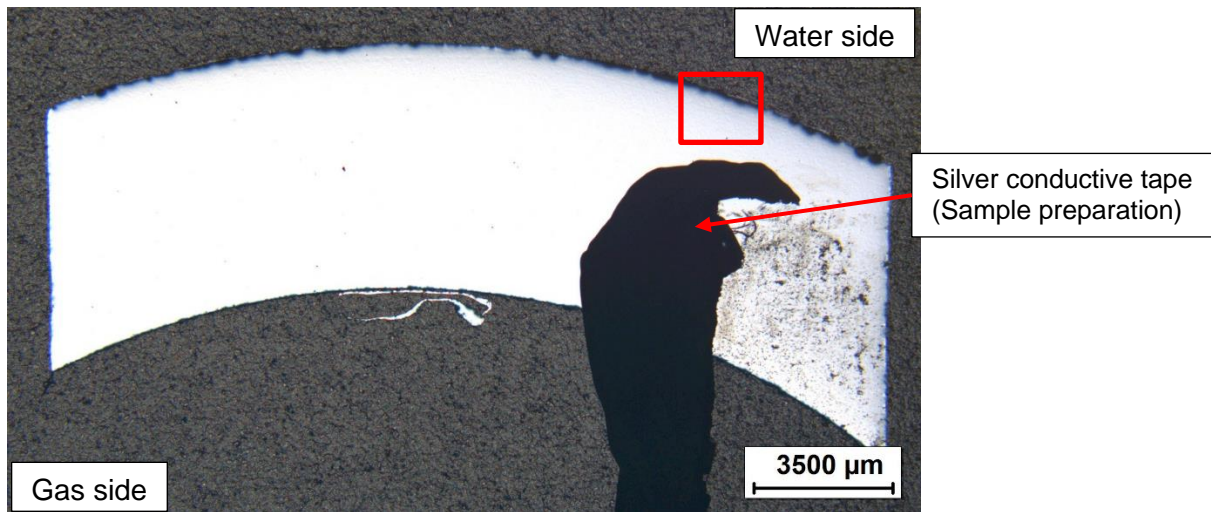
Fig. 4.4: Metallographic image of sample 4 cross section (see Fig. 2.6). Sample 4 is located on the opposite side of sample 2 (refer to Fig. 4.1). The surface is less corroded compared to sample 2. The red marked zone is seen in Fig. 4.5. The

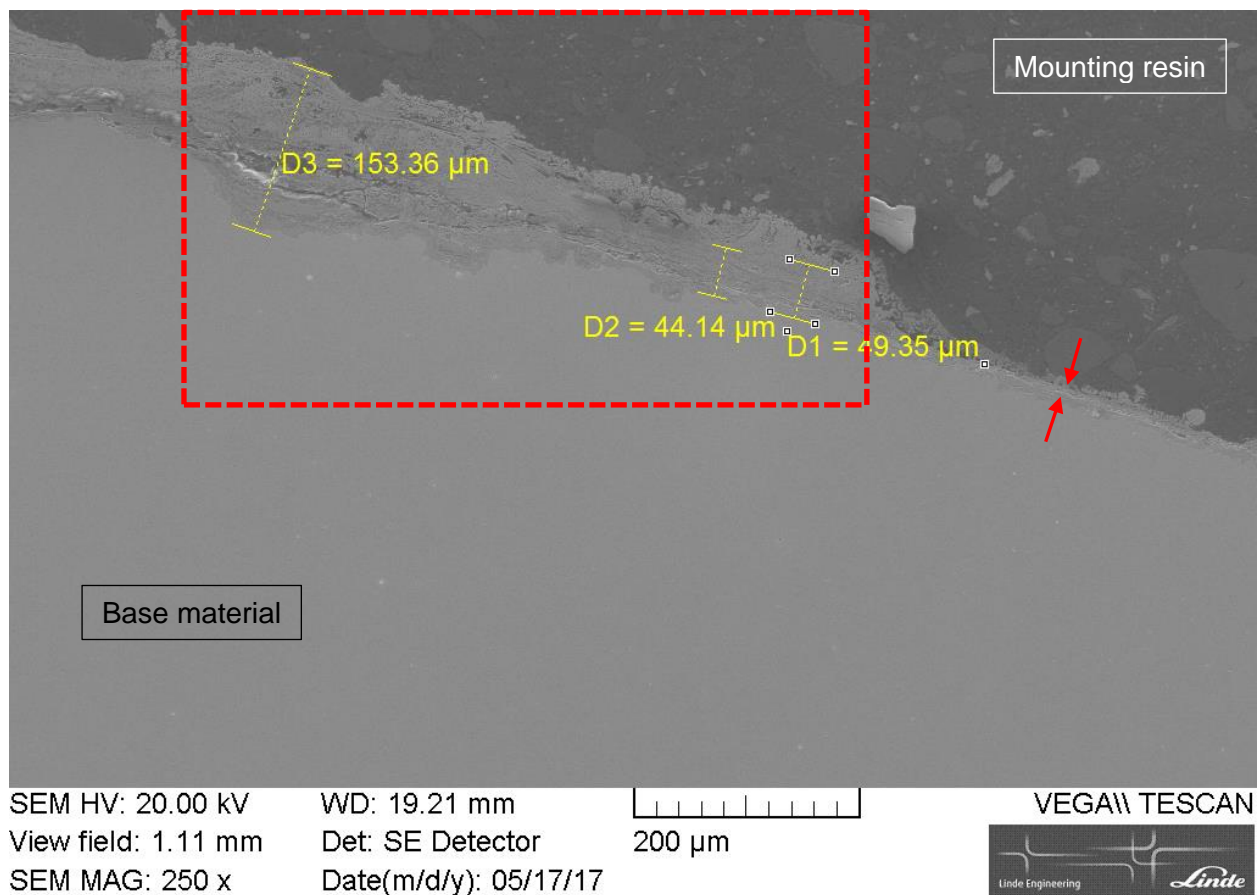
Fig. 4.5: SEM (Scanning Electron Microscopy) image of sample 4 for the area as seen in Fig. 4.4. The magnetite layer is much thinner compared to sample 2. The layer is inhomogeneous and deposits are seen underneath the magnetite layer. The red marked area is the reference for mapping as seen in Fig. 4.6.

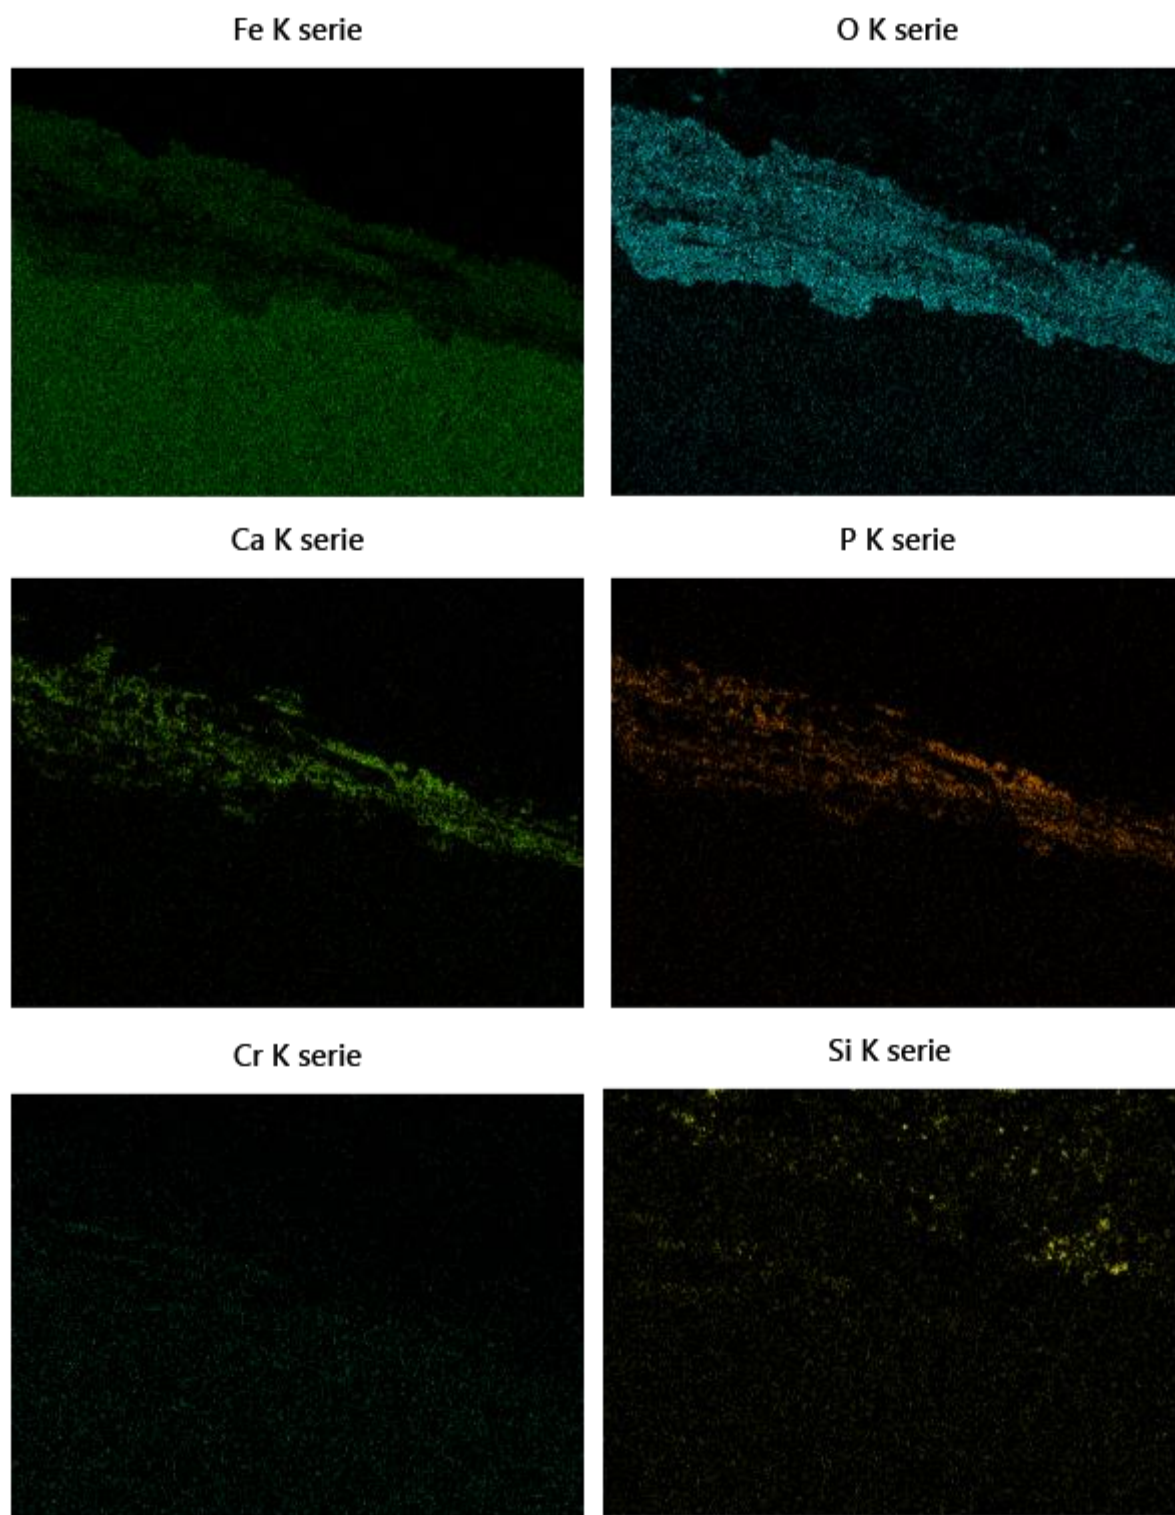
Fig. 4.6: Mapping of sample 4 of the surface shown in Fig. 4.5. Elements of P and Ca are found inside the porous layer.

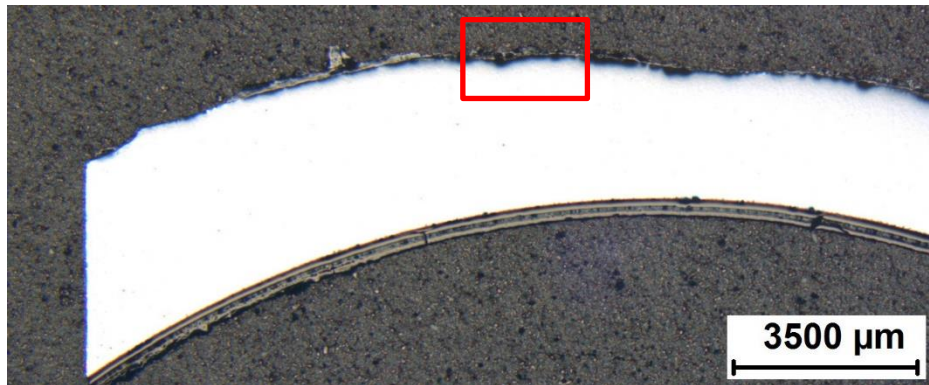
Fig. 4.7: Metallographic image of sample 1 cross section (refer to Fig. 2.6 for location). Sample 1 is located next to the tube sheet on the back of the tube (with respect to flow direction). The red marked area is seen in Fig. 4.8.

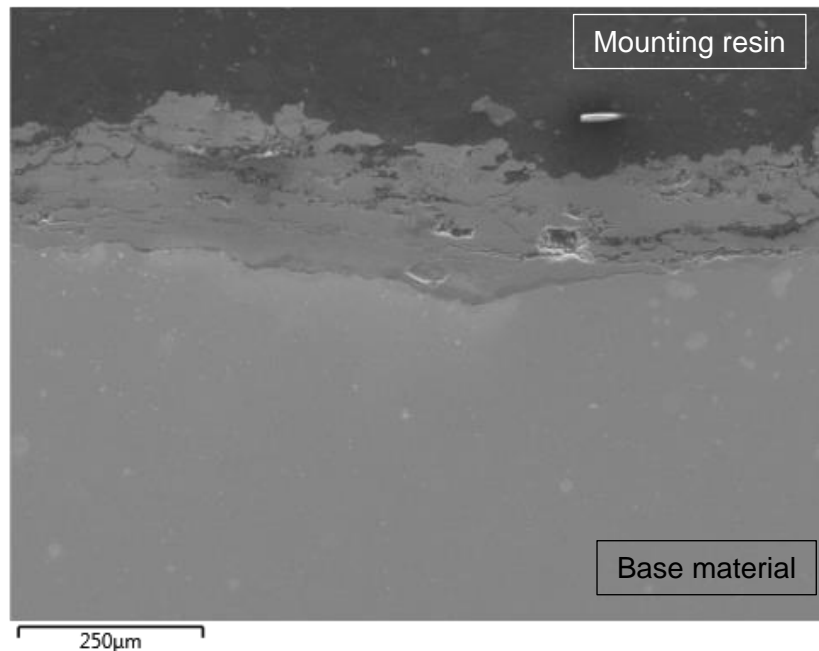
Fig. 4.8: SEM (Scanning Electron Microscopy) image of sample 1 for the area as seen in Fig. 4.7. An inhomogeneous magnetite layer is seen. The image will be the reference image of a mapping scan as seen in Fig. 4.9.

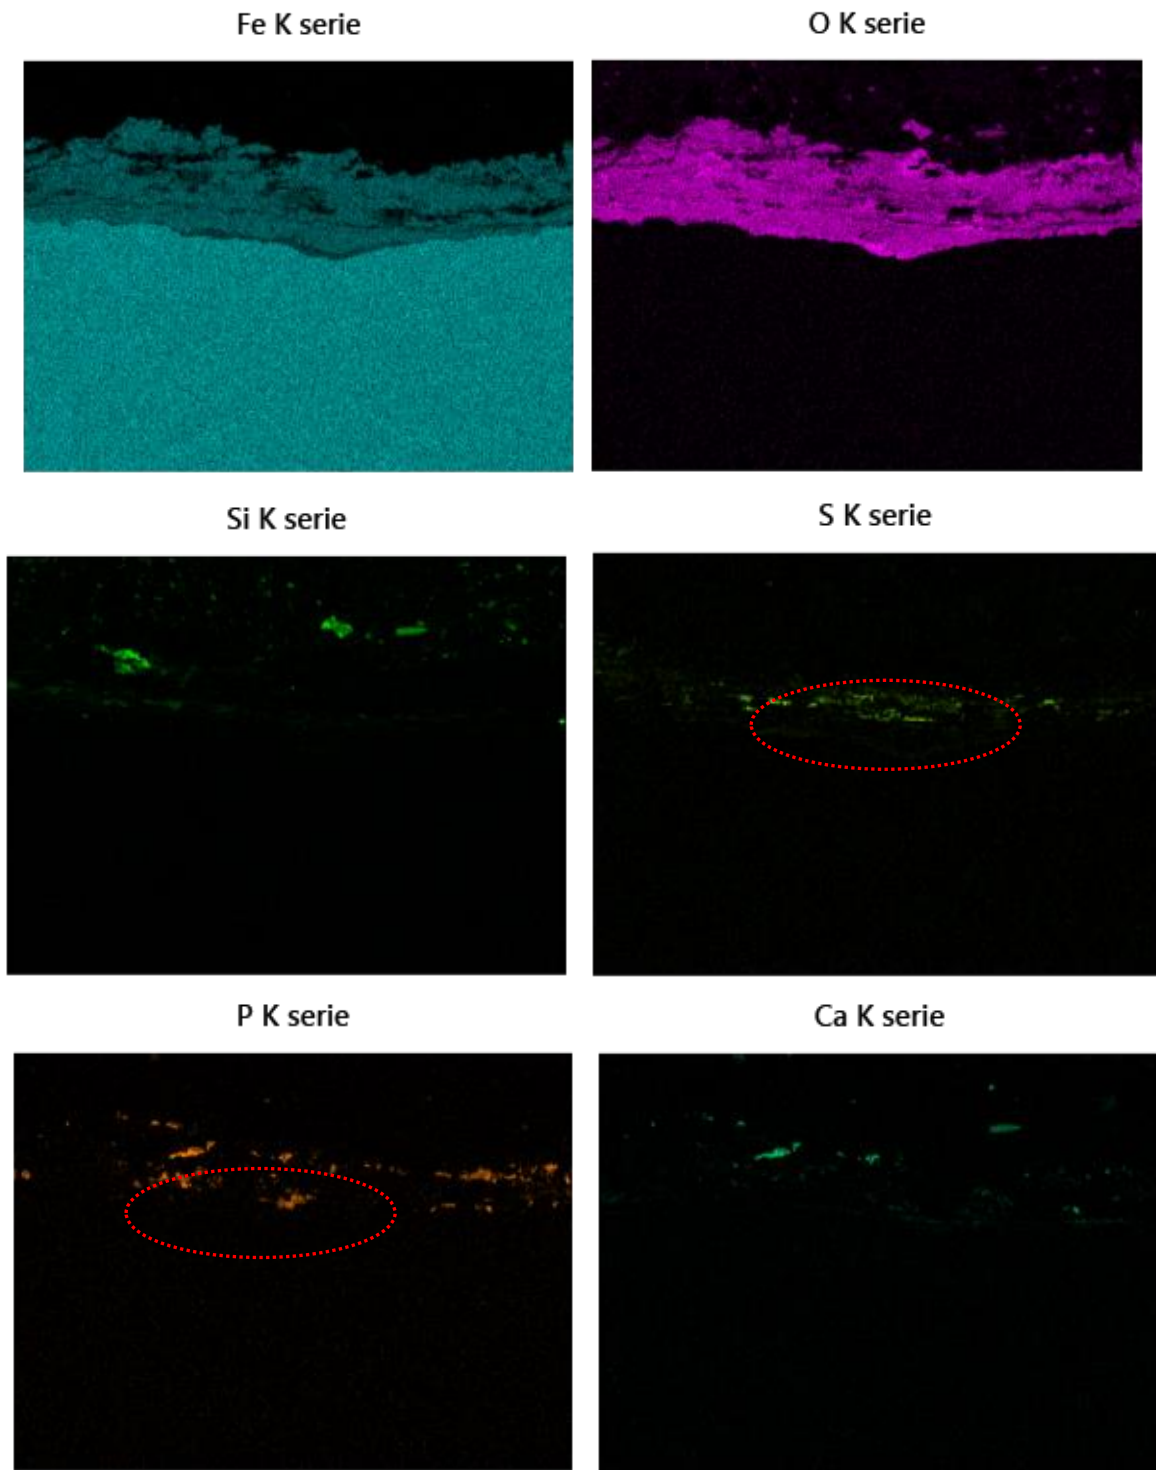
Fig. 4.9: Mapping of sample 1 of the surface shown in Fig. 4.8. The mapping revealed the S, Ca and P elements within and underneath the magnetite layer.

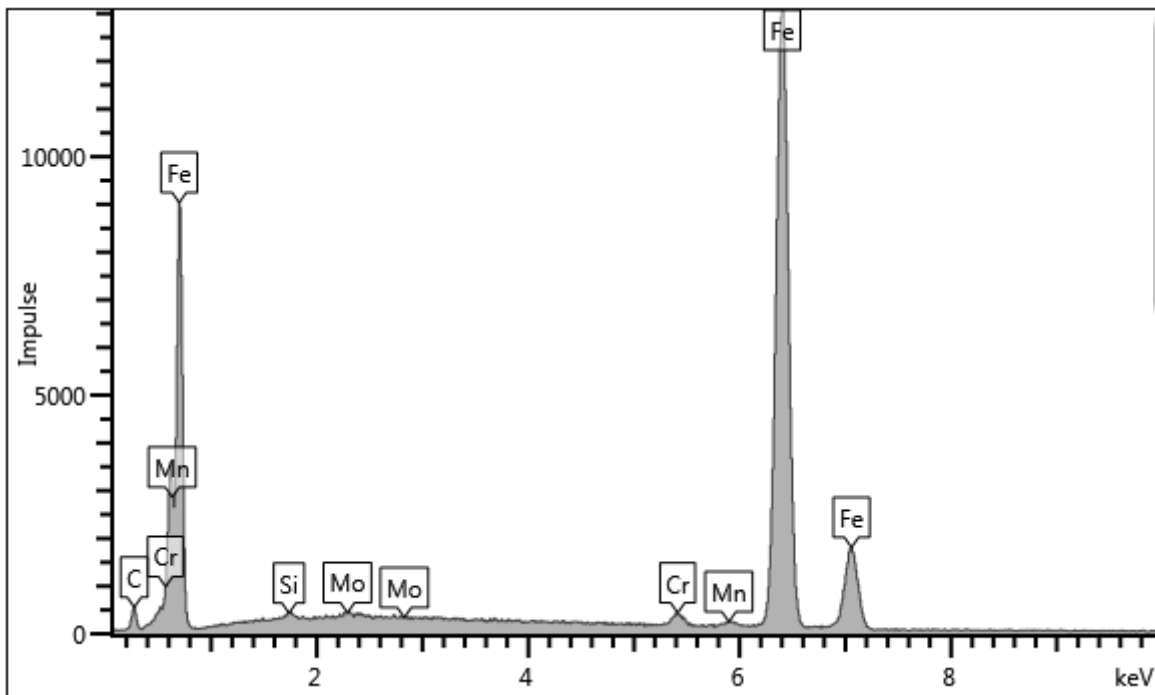
The Energy Disperse X-Ray (EDX analysis), as in Fig. 4.10, shows that the composition of the base material of the tube is in the range of the specified material.

Fig. 4.10: EDX (Energy Dispersive X-ray) analysis of pipe base material analysis. The base tube material is matching with the specified material.
