LINDE AG Linde Engineering Division	Damage of Transfer Line Exchanger Tube	Document No.
		TRT 17 So 026
Proj. No.: 3130 BGWM	Code: BANDAR_IMAM_JS1	Page 1 of 5

Target of this investigation is to find the root cause of this failure and to give recommendation for planned repair work on site.

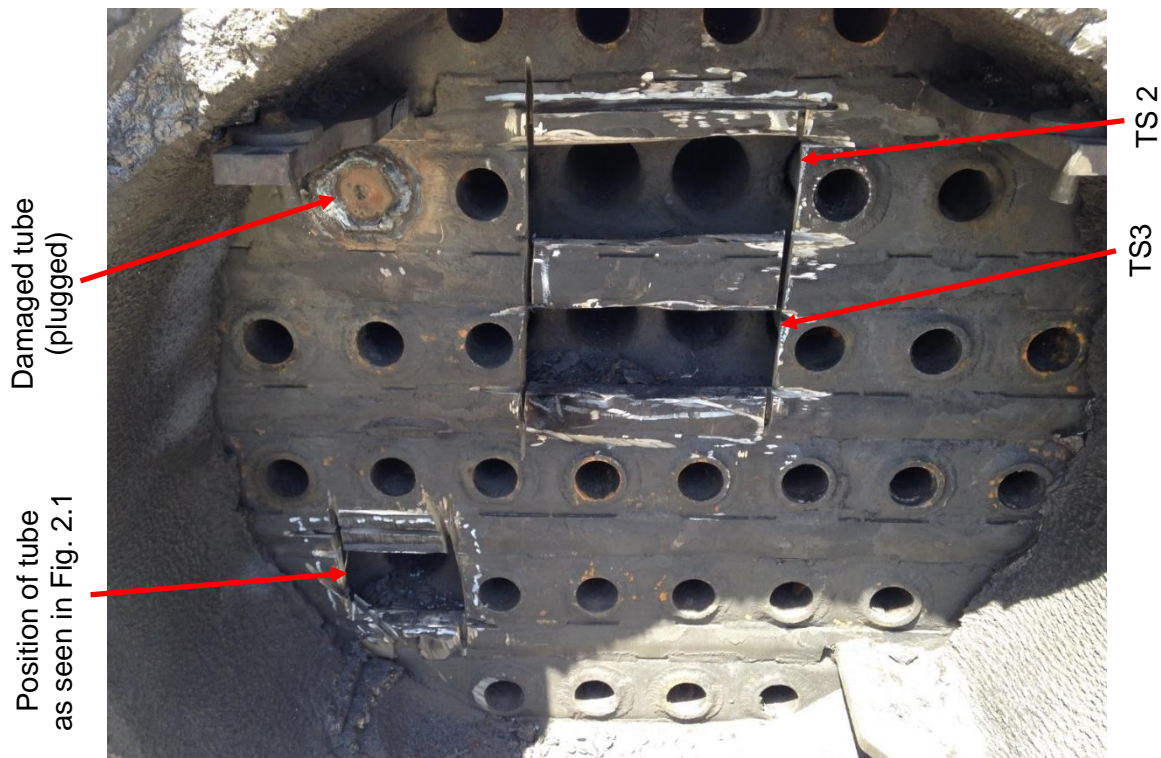
Simple dimension check of oval header width (of tube-sheets cut as in Fig. 2.2) shows discrepancy. Nevertheless, tools used/measuring possibilities were not ideal and hence no conclusions can be made whether dimensions of the manufactured TLEs are matching the technical drawing. In this regard, it was noted that oval headers have different flow rates as per Schmidt'sche® design and hence, oval headers must have different dimensions. Since leaks occurred in tubes located at the end of oval header (among last tubes of a row with dead end), assumption is made that these locations are of highest water temperature. Material loss due to corrosion took place at the backside of the tubes (with respect to flow direction). These factors combined can lead to an accelerated corrosion.

Fig. 2.2: Tube sheet view of TLE C of furnace 4 after removing of selected samples. TS 2 and TS 3 represent the samples of 2nd and 3rd row respectively which was cut out of the tube sheet.

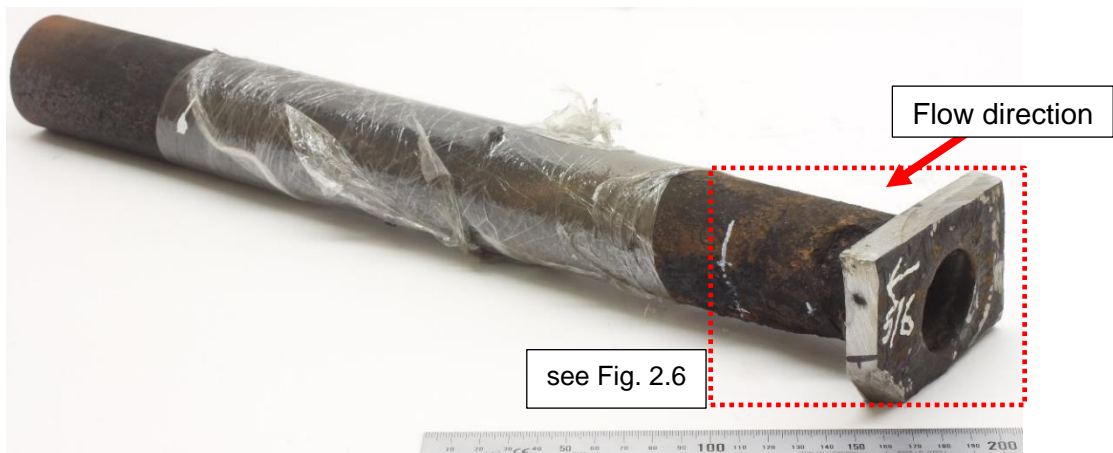
Fig. 2.5: Overview of the cut tube as seen in Fig. 2.2. Tube from 6th row, tube No. 5 from furnace 4 C (TL 1411C). The flow direction is shown. Cross section samples were obtained from the red dotted area as seen in Fig. 2.6.

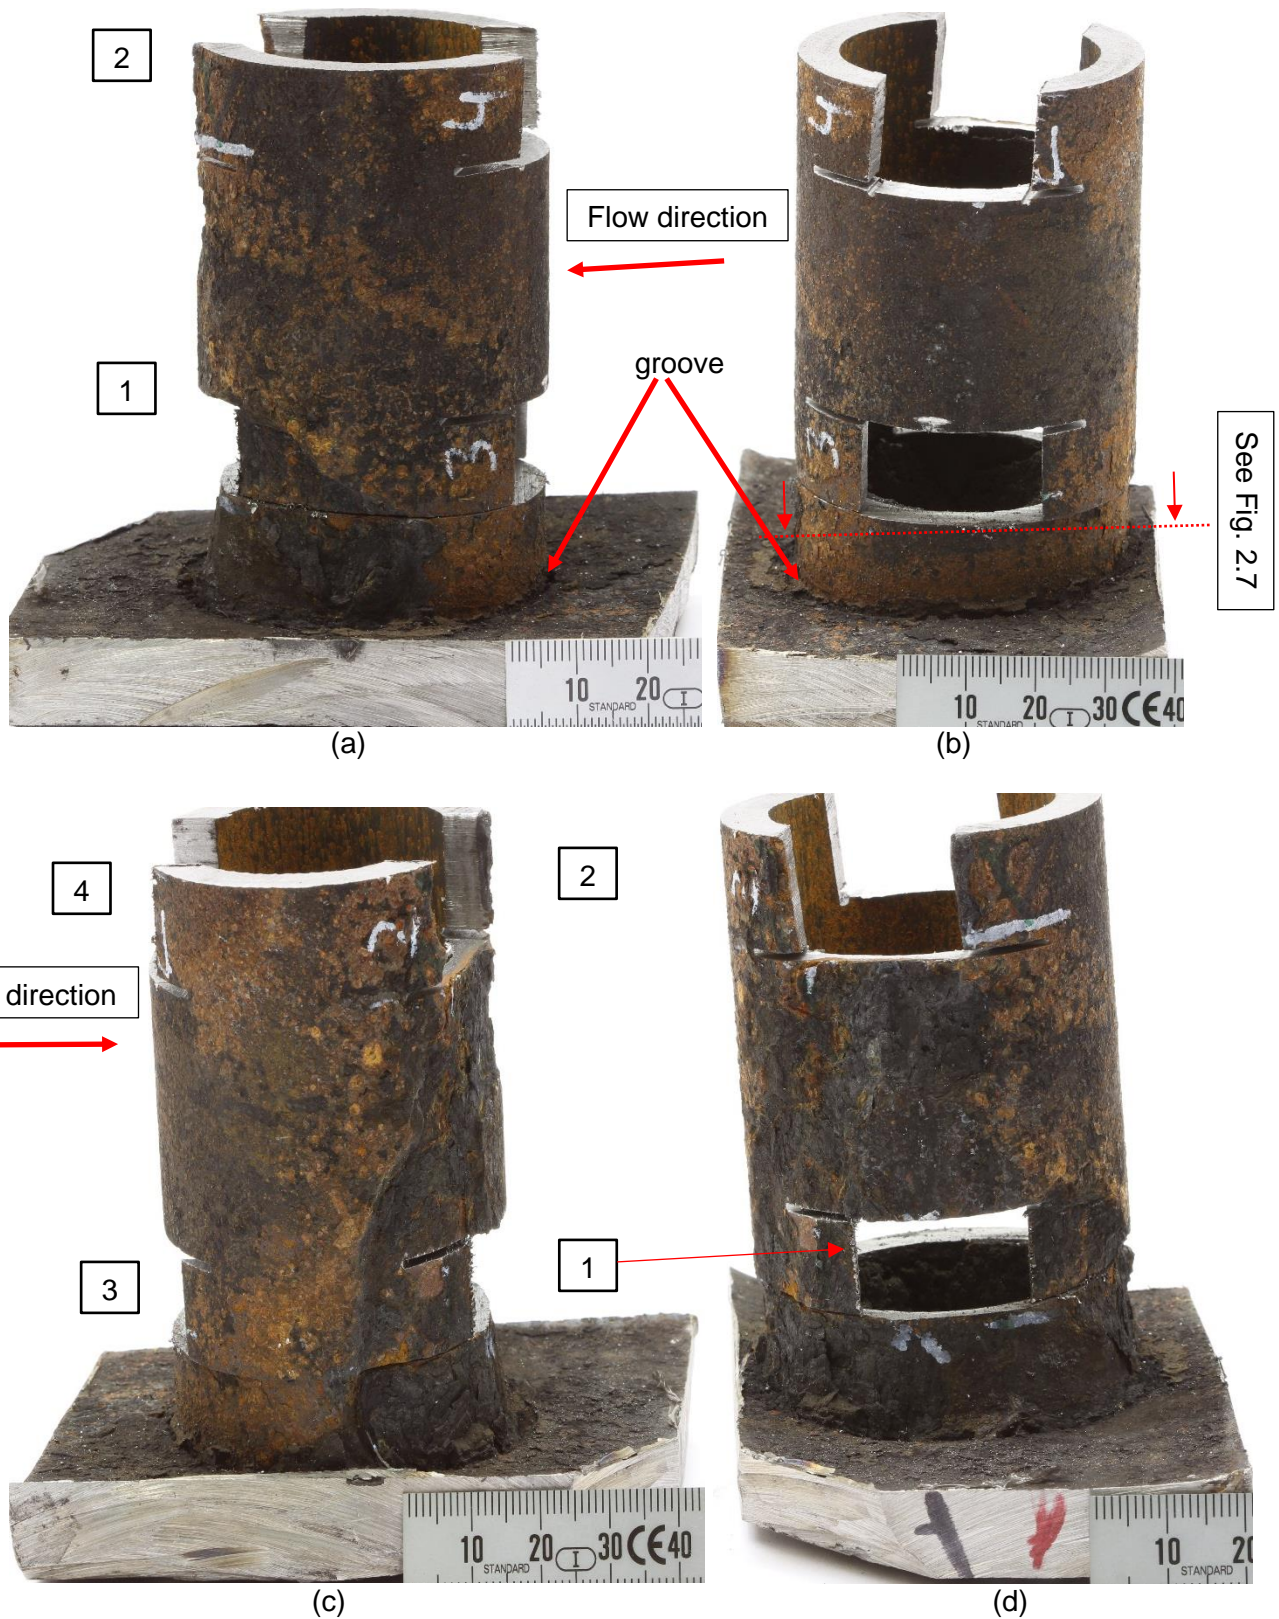
Fig. 2.6: View of samples cut out of tube No. 5 of 6th row, furnace 4 TLE C (refer to Fig. 2.3). In total 4 samples were cut out for further investigation as seen above. The flow direction is given; hence sample 1 & 2 are at the back of the tube with respect to the flow direction.
